CONDITION SURVEY OF
DEPERE LOCK AND DAM
LOWER FOX RIVER, WISCONSIN

Richard L. Stowe, Joyce C. Ahlvin

June 1982

CONDITION SURVEY OF DEPERE LOCK AND DAM
LOWER FOX RIVER, WISCONSIN

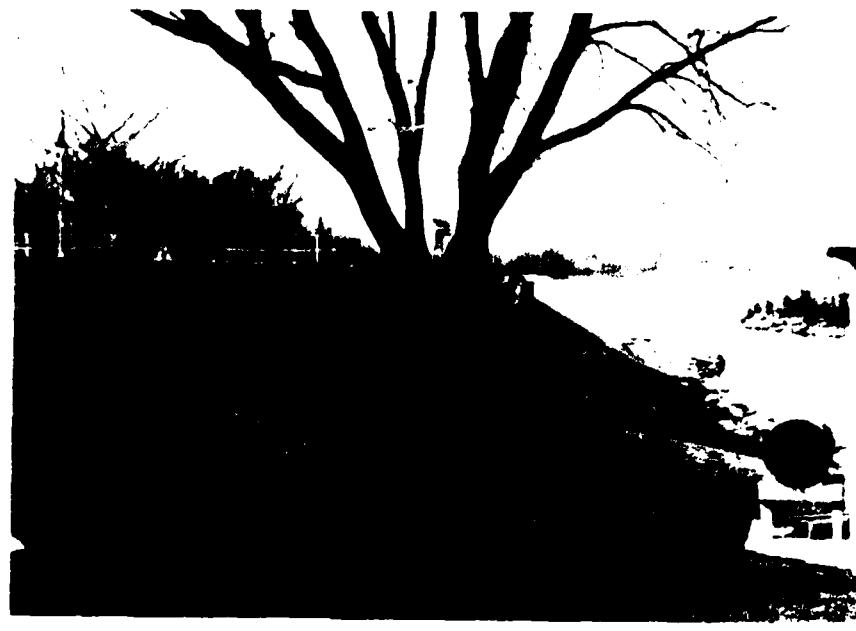
13. The grassed embankment adjacent to both lock walls appears in good condition with local areas showing a little differential settlement in the order of 5 to 9 in. The side slopes are about 1 vertical to 2 horizontal. There is no evidence of seepage. (See Photos 8 and 9 (Appendix A).)

Photo 8. Taken from near upper gates on right side of lock embankment, looking downstream, minor settlement evident but embankment in good condition.

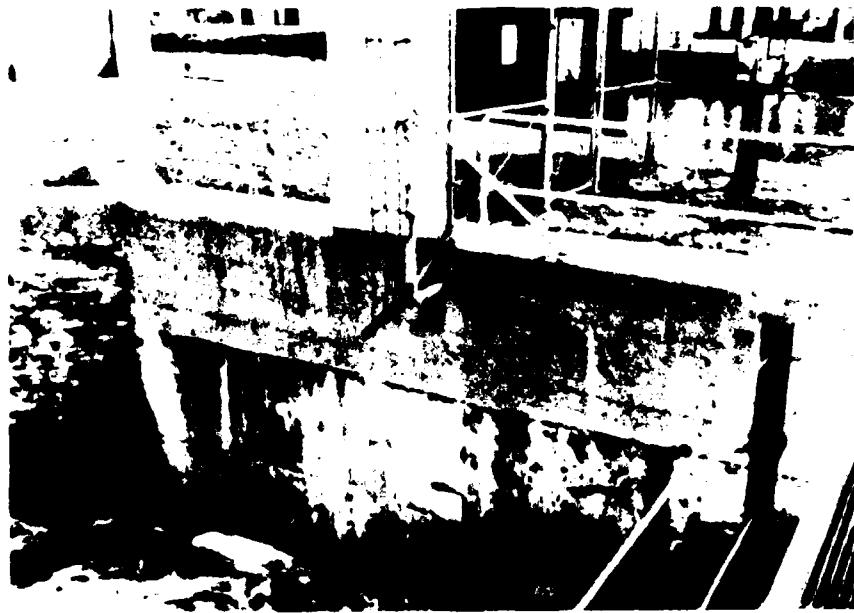
Photo 11. Taken from right spillway, looking at downstream portion of right dam abutment pier. Top concrete in good condition. White exudation coming from horizontal joint and cracks.

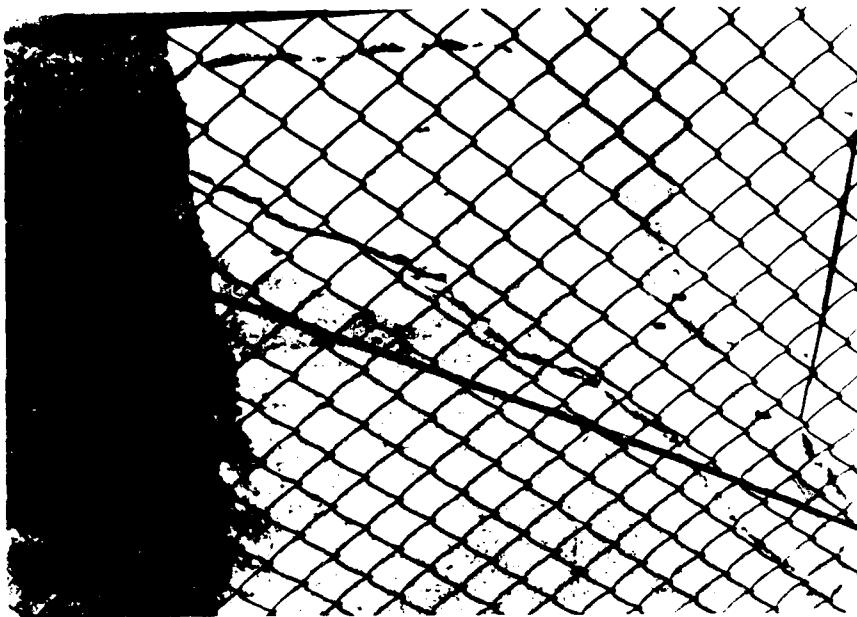
15. The upstream portion of the abutment pier is in good condition except for an approximate 10-ft-long by 2-ft-deep wedge of concrete at the top of the pier. (See Photos 10 and 12, Appendix A.) A wide

crack (>2 mm, 0.08 in.) can be seen on the top and dam side of the pier. Photo 12 (Appendix A) shows relative movement along the crack. There is no concern about the stability of the pier due to this crack. However, the crack should be measured periodically; if large movement occurs, remedial measures can be taken.

Photo 12. Taken from right abutment, looking upstream at wide crack on top of abutment pier. Cracked section of concrete appears raised.

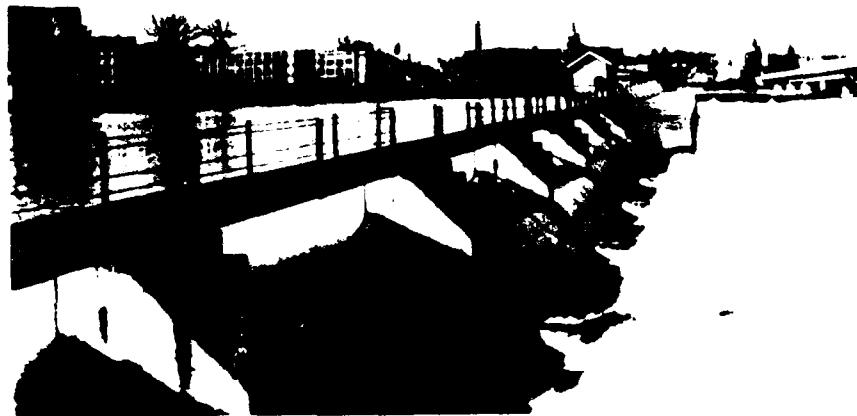
Photo 13. Taken from right dam abutment, looking across right spillway. Minor amount of white exudation and cracking; spillway pier No. 1.

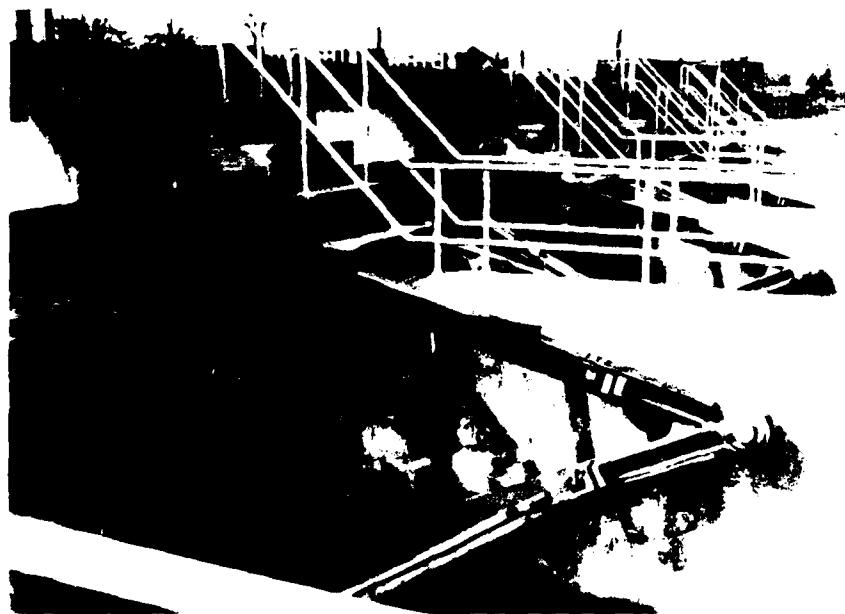
17. The condition of the concrete in the sluiceway piers is generally good (see Photos 15 through 18, Appendix A). Damage due to freezing and thawing is confined to local areas; the presence of cracks and exudation is evidence of the damage. Small areas of concrete in the piers at and near low pool elevation have been eroded by water and ice action. A few piers have cracks through the piers near the gate hinge pins. Cracks are similarly located in the piers of Cedars Dam on the Lower Fox River. The Chicago District conducted a stability analysis of the cracked concrete piers at Cedars Dam and determined that reinforcement within the piers was effective for gate loads; see Reference 1, Appendix B, page B-4. The analysis made for the piers at Cedars is applicable for the piers at DePere; they have the same dimensions and reinforcement.

Photo 15. Taken from sluiceway pier No. 10, looking upstream. Except for local cracking and exudation, concrete is in generally good condition.

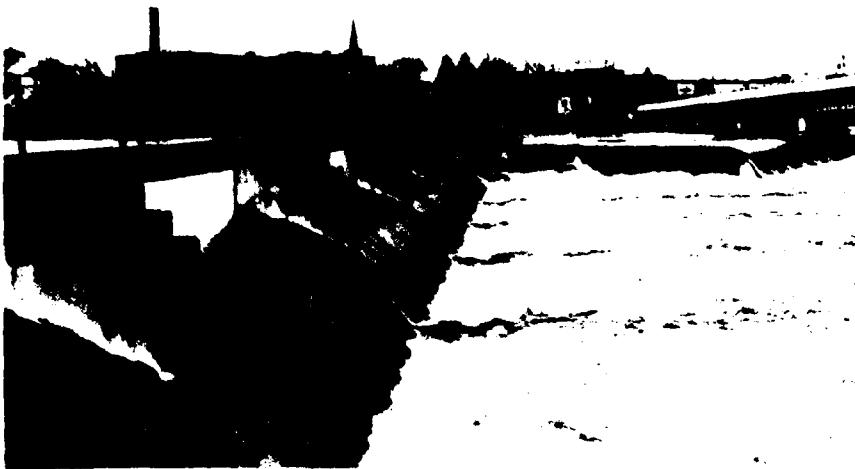
19. The concrete in the foot bridge piers is in generally good condition. Local cracking and exudation is present. See Photos 19 through 21, Appendix A. Light erosion is present near the waterline of the piers; see Photo 22, Appendix A. Concrete repair on the noses of several piers is in good condition. Repair of the damaged concrete could be done during routine maintenance.

Photo 19. Taken from sluiceway pier No. 15, looking across left spillway, concrete in pier in good condition. Private dam seen just downstream of left abutment.

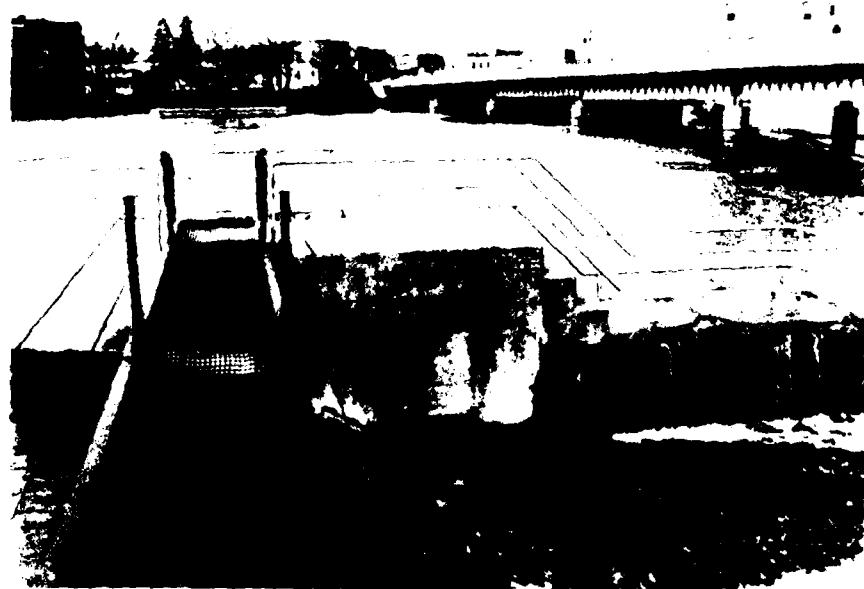
20. The concrete in the middle and the upstream portions of the left abutment pier is in good condition; a few cracks, some exudation, and light erosion is present. The uppermost downstream portion of the pier (see Photo 23, Appendix A) is heavily deteriorated. This portion of the pier is partly submerged and has sustained more freezing and thawing damage than the remaining concrete in the pier because it is critically saturated. Erosion (by water and ice) has also caused some of the damage. Reinforcing steel is exposed at the downstream face of the pier but only at the waterline.

Photo 23. Taken from left spillway, looking at left dam abutment pier.

21. It would be wise to check the integrity of the internal concrete in this section of the pier. If the internal concrete is sound, then repair to the external concrete can be made during routine maintenance. Nondestructive tests, such as ultrasonic velocity measurements, could be made to check the soundness of the internal concrete; core borings could likewise be used.

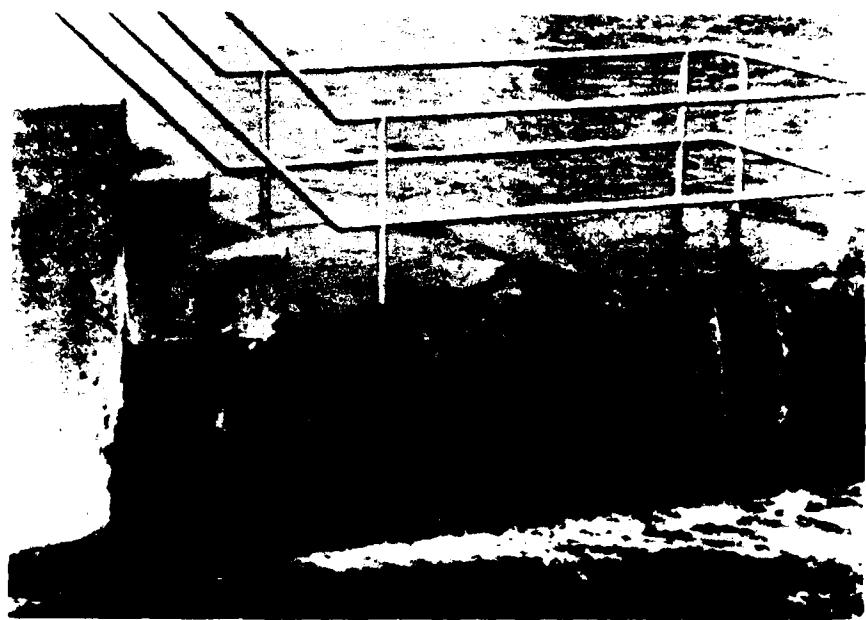
Photo 24. Close-up of downstream end of left abutment pier.
